Manhole Inspection Summary

Manhole # S63M__012MH

Location Address: **5501 O'Donnell St.**

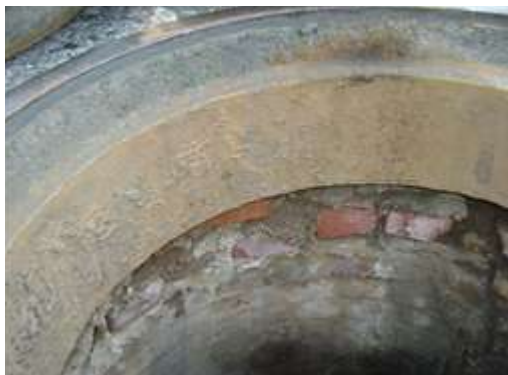
Defect 2

Condition: ☐ Sound ☐ Cracked ☐ Root Intrusion ☒ **Loose Brick** ☒ **Deteriorated**

Loose Bricks

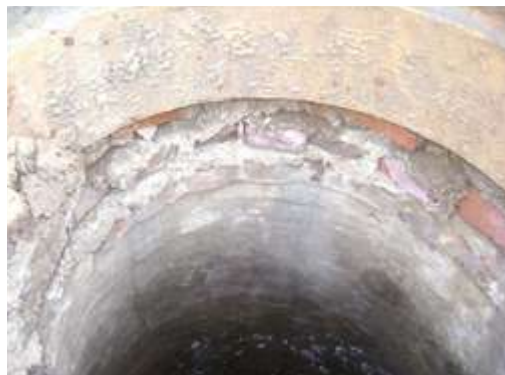
Defect 3

Infiltration: ☐ None ☒ **Joint** ☐ Cracks ☒ **Mortar** ☐ Roots ☐ Wall

Deteriorated mortar under frame

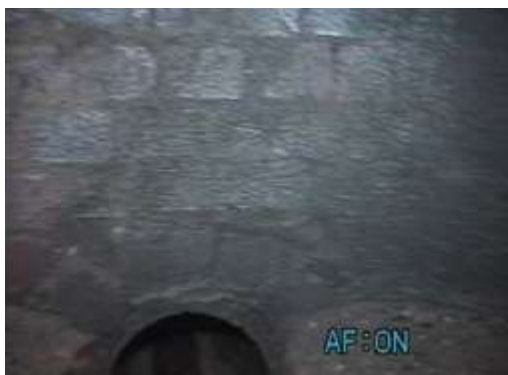
Defect 4

Infiltration

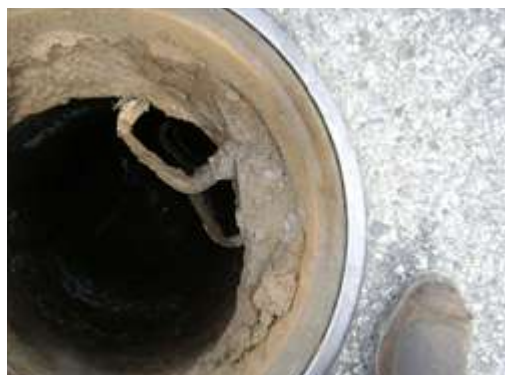
Defect 1

Offset: **3** (in.)

Condition: ☐ Sound ☒ **Cracked** ☐ Leaks

Offset frame

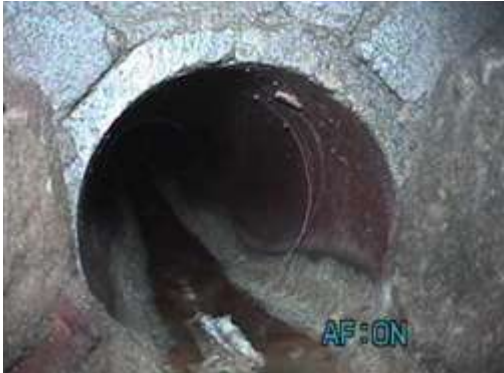
Defect 5

fracture circumferential 12:00-7:00 in 12 o'clock pipe

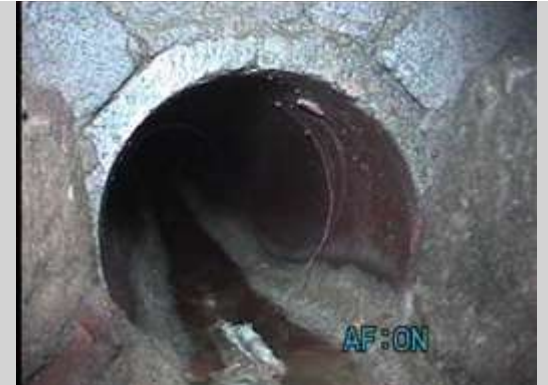
12 O'Clock Outflow

Pipe Height: **8.4** (in.) Rod and Bar (Angled)
Pipe Material: **Clay** ☐ Pipe Lined
Invert Depth: **13.42** (ft.) Flow Characteristics: **Slow**
Deposits: ☒ None ☐ Mud ☐ Gravy ☐ Debris ☐ Grease
Silt Depth: (in.) Deposits Extent:
Infiltration: **None** Pipe Seal Cond: **Sound**

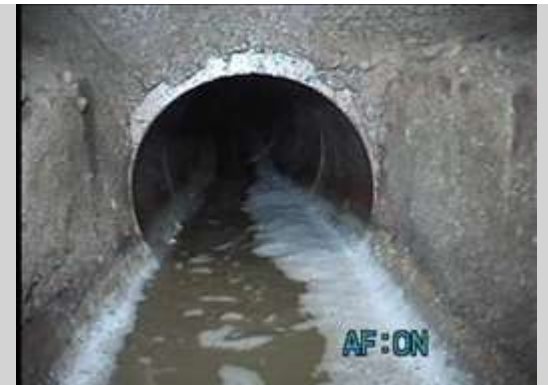
6 O'Clock Inflow

Pipe Height: **8.4** (in.) Rod and Bar (Angled)
Pipe Material: **Clay** ☐ Pipe Lined
Invert Depth: **13.33** (ft.) Flow Characteristics: **Slow**
Deposits: ☒ None ☐ Mud ☐ Gravy ☐ Debris ☐ Grease
Silt Depth: (in.) Deposits Extent:
Infiltration: **None** Pipe Seal Cond: **Sound**

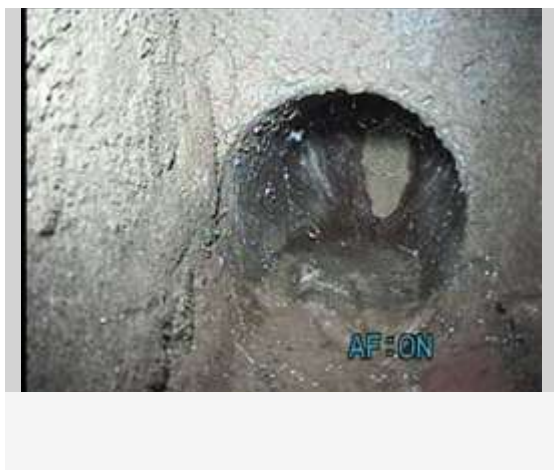
9 O'Clock Inflow

Deposits: ☐ None ☐ Mud ☒ **Sludge** ☐ Debris ☐ Grease

Silt Depth: **0.5** (in.) Deposits Extent: **Light**
